NASA Contractor Report 172371

Flight Service Evaluation of Two Aluminum-Brazed Titanium Spoilers

R. R. Boyer

**Boeing Commercial Airplane Company
Seattle, Washington**

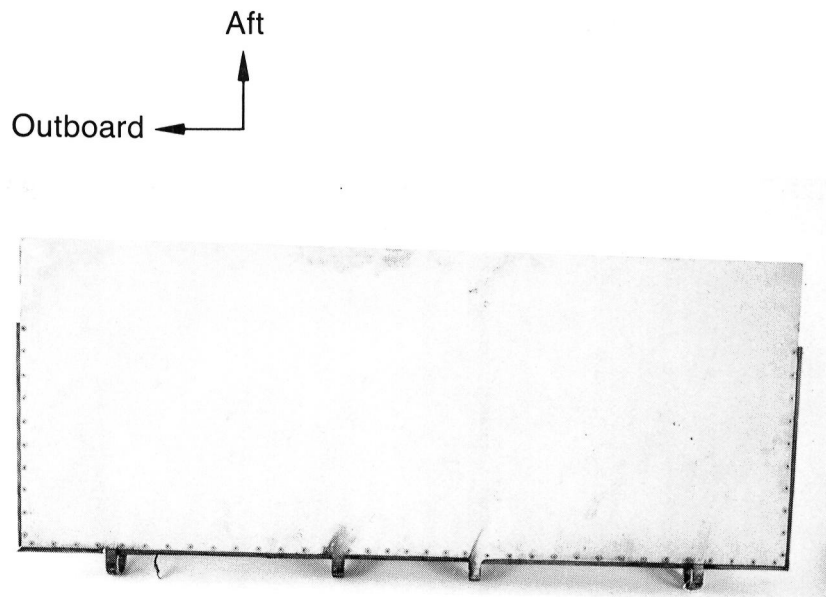
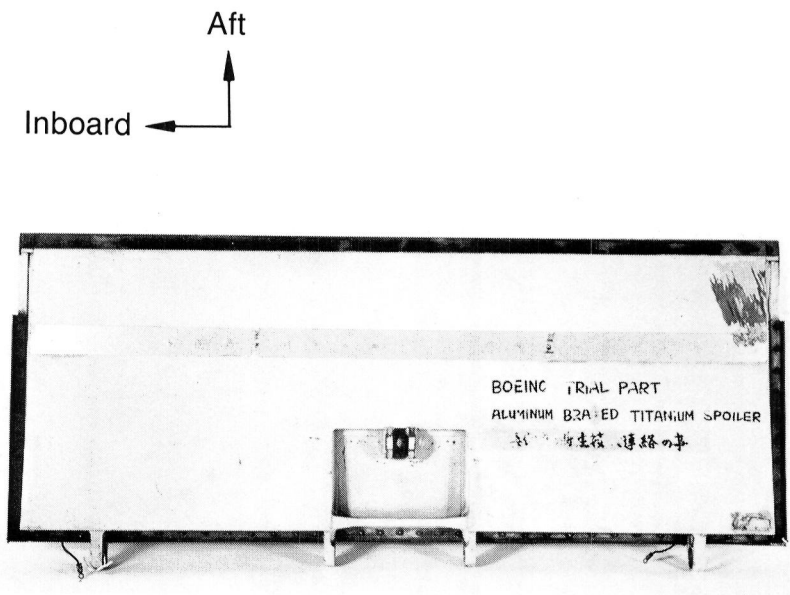
Figure 10. Flight Spoiler S/N 002 After About Eight Years of Service

- The spoilers were removed and inspected at Boeing in Seattle.
- Structurally, the spoilers appeared to be in excellent condition.
- There was evidence of paint loss on both spoilers due to rubbing or abrasion, as shown in Figures 10 and 11. The paint on the exposed surface of the center yoke fitting (lower surface) was extensively blistered due to Skydrol (Fig. 12). There was some blistering on the lower

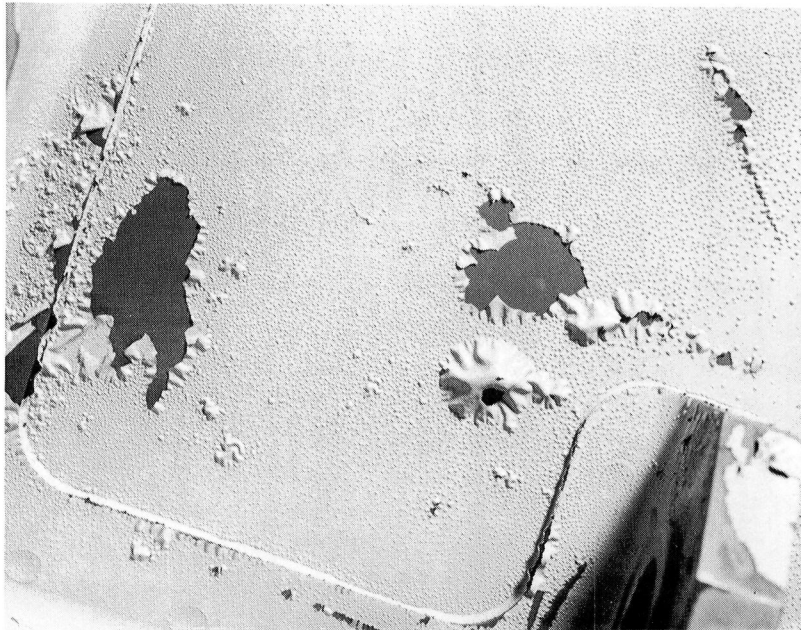
Figure 12. Paint Blistering and Peeling Due to Skydrol on Center Yoke Fitting, Spoiler S/N 002

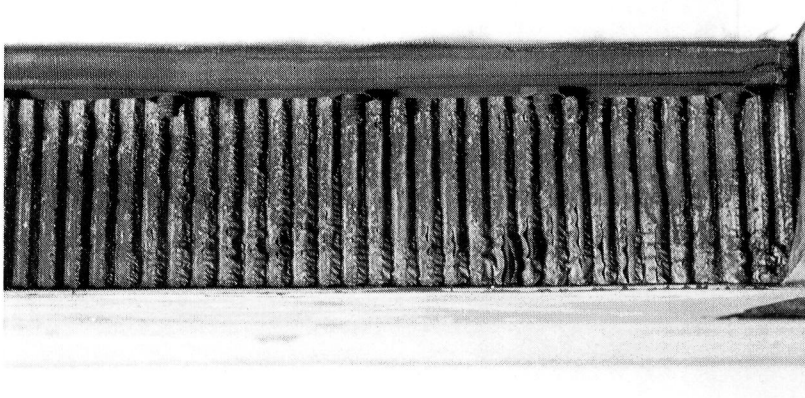
skin surface adjacent to the yoke. This was more prevalent on spoiler S/N 002 on the outboard portion of the skin. The worst paint problem occurred on the leading-edge core (Fig. 13). None of this blistering or actual peeling of paint, particularly on the core, led to any corrosion.

Figure 13. Paint Blistering and Peeling Due to Skydrol, Typical of Leading-Edge Core

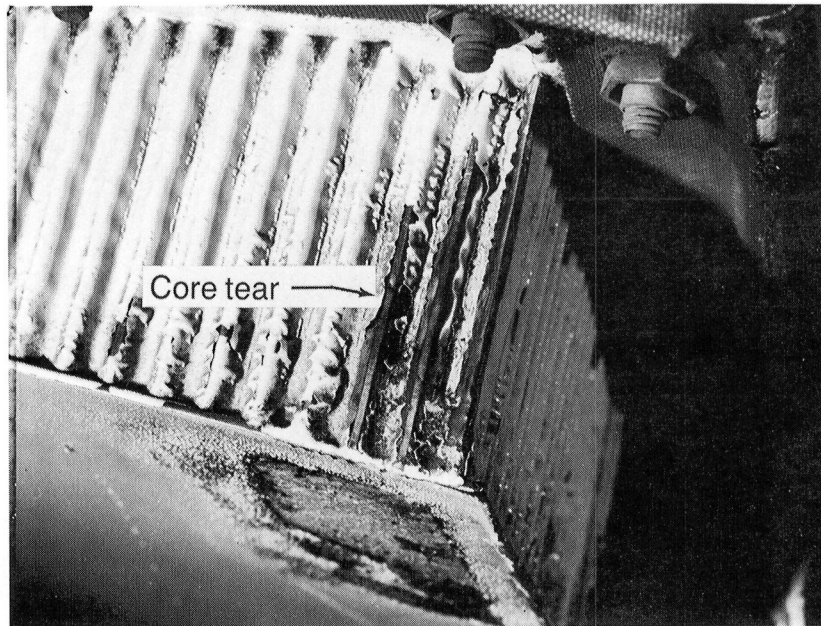
- Some damage to the exterior core had occurred. A core node right at the leading edge outboard corner almost appeared to have been cut on spoiler S/N 002 (Fig. 14). The extent of the opening was about 1.3 cm (0.5 in.). (Damage was reported in this area in the 1979 on-site inspection.) Spoiler S/N 003 had damage to both the inboard and outboard edges. It appeared to have been hit and torn apart on the lower surface. On the outboard surface, there was a disbond across three cells—1.9 cm (0.75 in.)—about 1.5 cm (0.6 in.) aft of the leading edge (Fig. 15). On the inboard surface, there were three damage regions (Fig. 16). One cell, about 4.1 cm (1.6 in.) aft of the leading edge, appeared to have been struck by a sharp object. The second and third cells aft of the leading edge also appeared to have been torn loose on the lower surface. The corner node apparently was struck by a dull object and torn open. There was no evidence of corrosion at any of these sites.

Figure 14. Damaged Core Observed at Leading Edge, Outboard Core, Spoiler S/N 002

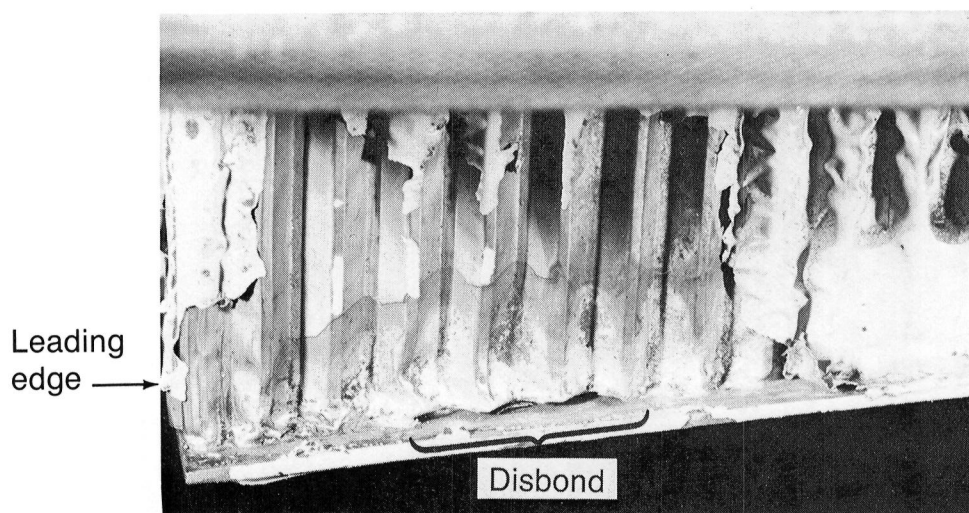
Figure 15. Disbond on Lower Surface, Outboard Edge, Spoiler S/N 003

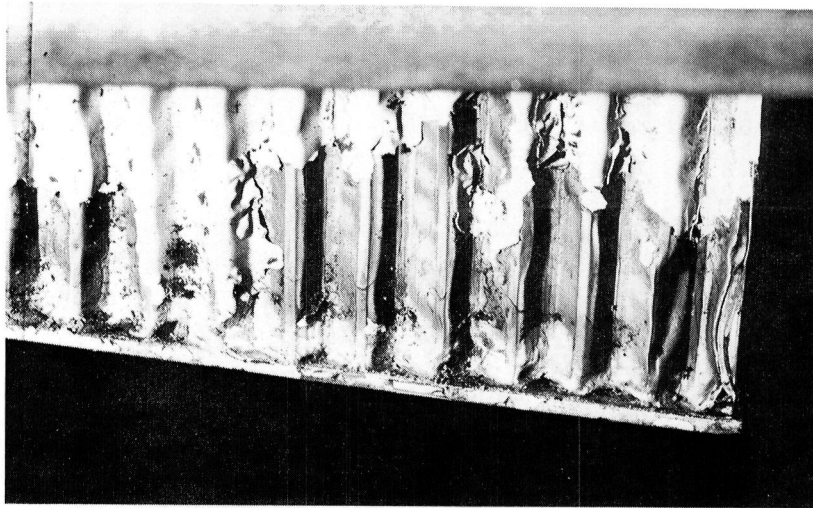
Note hole at corner node, obviously hit by a dull object. Second and third cells aft are disbonded, and there is an apparent puncture five cells farther aft.

Figure 16. Damaged Areas Near Leading Edge at Inboard Lower Surface, Spoiler S/N 003

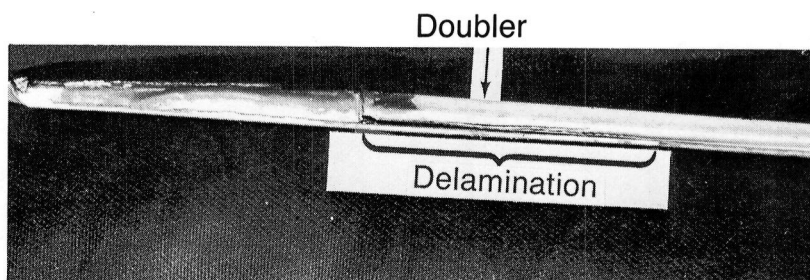
- The repaired doublers on spoiler S/N 003 were delaminated forward to the repair fasteners. The doublers on spoiler S/N 002, which were not riveted, were delaminated about 2.3 cm (0.9 in.) on the inboard side and 2.5 cm (1 in.) on the outboard side (Fig. 17).

Extent of delamination about 2.3 cm (0.9 in.)

Figure 17. Doubler Delamination on Inboard Side, Spoiler S/N 002

All other problems noted were superficial. The doubler delamination was resolved by using flush-head fasteners, as in the repair of spoiler S/N 003. The paint blistering and peeling created only a cosmetic problem, not a functional one. The same problem is encountered with aluminum structure. As mentioned previously, the corrosion noted on the heads of the leading-edge seal fasteners was minor.

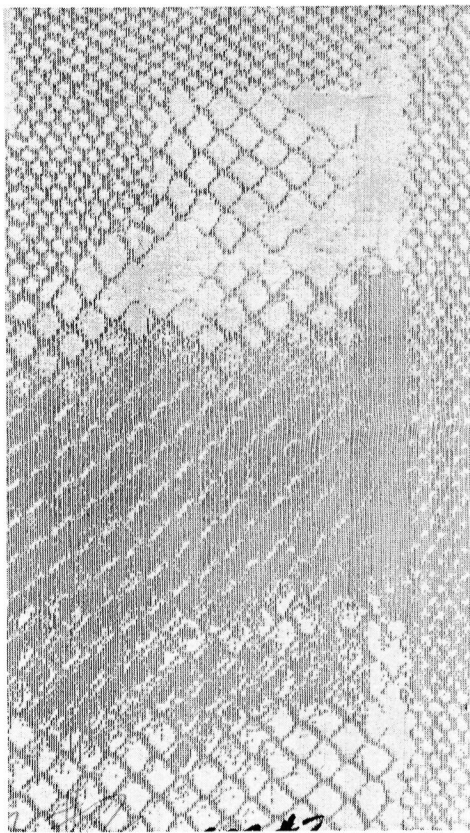
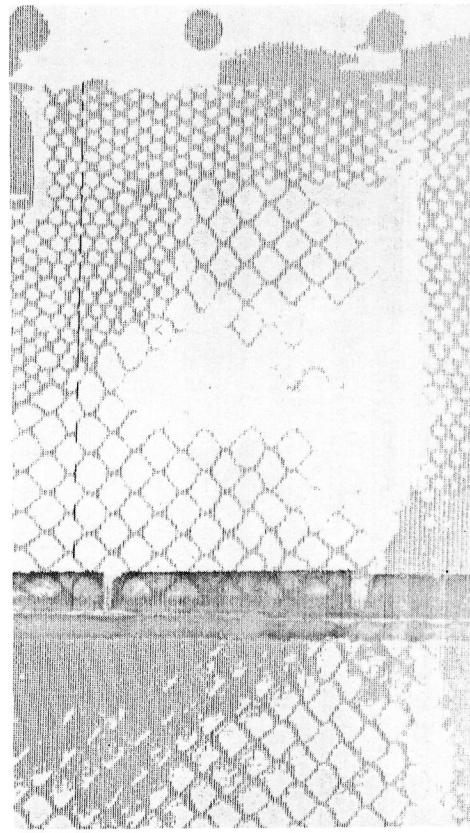
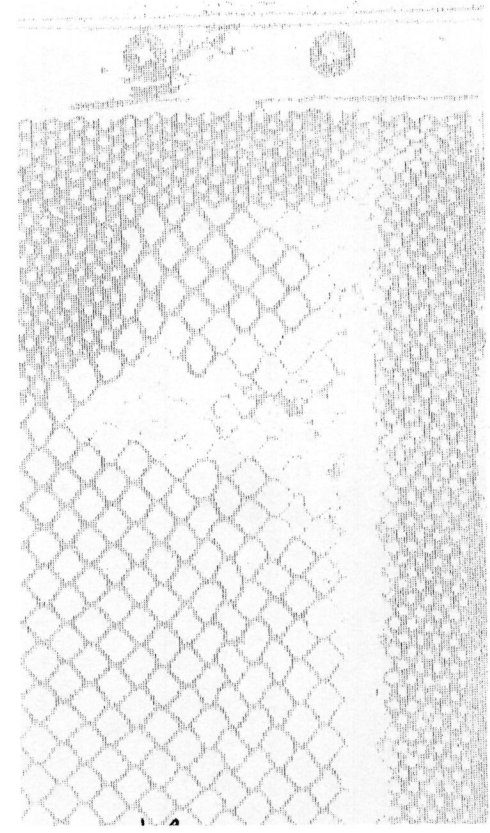
The initial inspection revealed two void areas. Spoiler S/N 002 had a fairly large void at the inboard edge of the SC 4-20 core, adjacent to the peripheral high-density core, near the leading edge. Figure 18 presents the 1973, 1976, and 1983 C-scans of the upper surface. The void was about 15.9 cm (6.25 in.) long and about 6.4 cm (2.5 in.) deep at its widest point. The void was not quite as long on the lower surface; it extended aft about 8.9 cm (3.5 in.) and was about the same maximum depth, 6.4 cm (2.5 in.) (Fig. 19). (The 1973 C-scan for the lower surface was misplaced.) The data from these ultrasonic C-scans are very encouraging. It is difficult to precisely trace the shape of the void through the years due to differences in quality of the C-scans, but the void does not appear to have grown through the approximately 8 years of service.

Figure 18. Pulse-Echo Ultrasonic C-Scans of Spoiler S/N 002, Upper Surface, Showing Braze Defect in Area of Inboard Leading Edge as a Function of Time

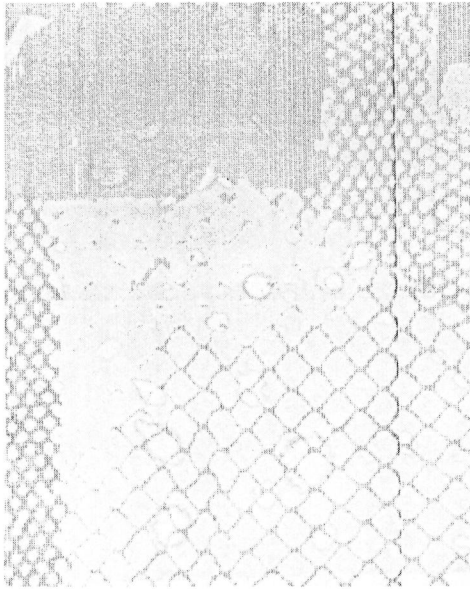
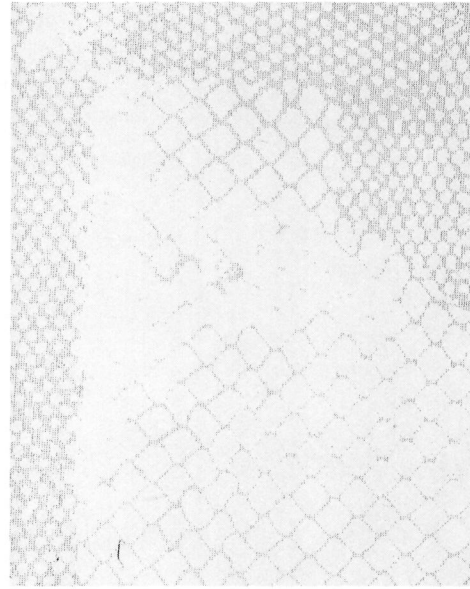
Figure 19. Pulse-Echo Ultrasonic C-Scans of Spoiler S/N 002, Lower Surface, Showing Braze Defect in Area of Inboard Leading Edge as a Function of Time

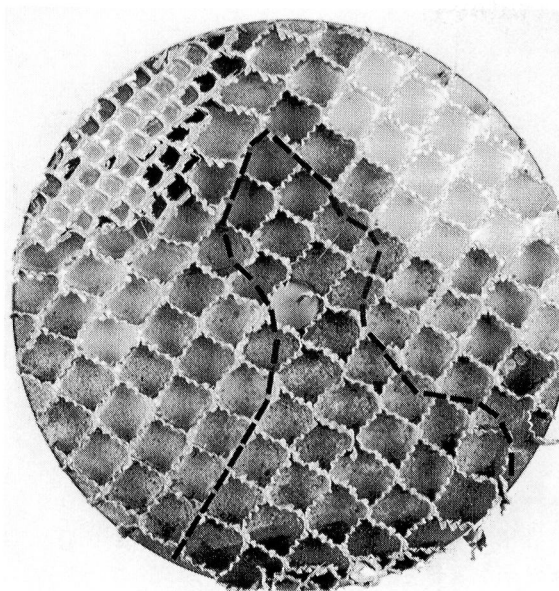
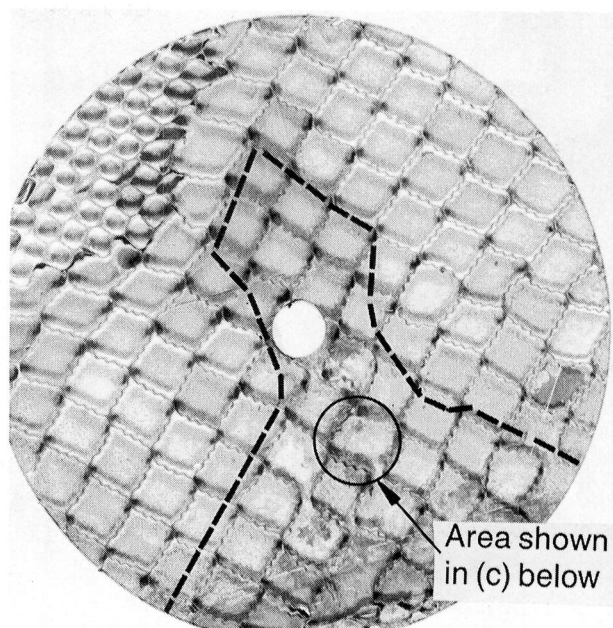
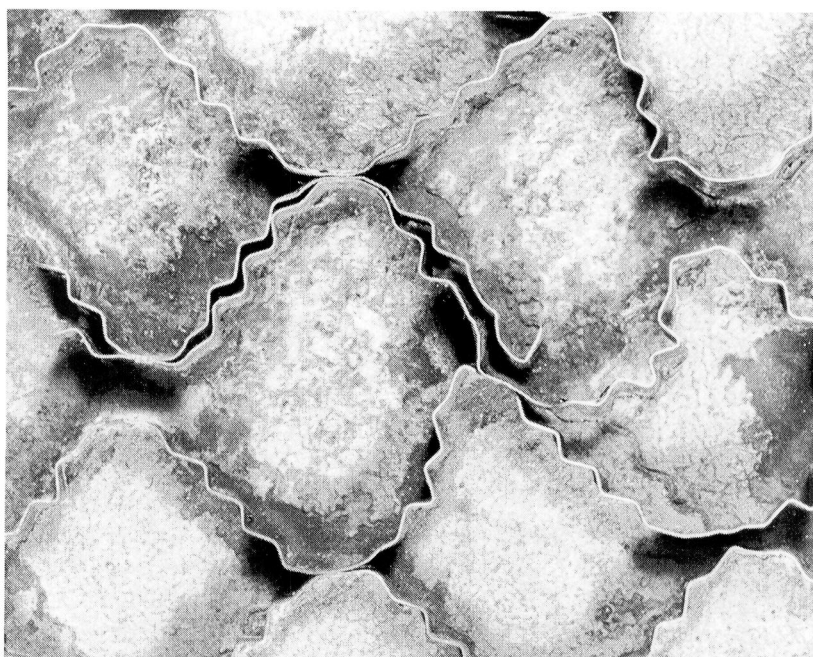
The void area was excised from the spoiler for analysis. The excised specimen was cut in half through the core (and the core ground down to a minimal core height to facilitate examination), so that the brazes on the upper and lower surfaces could be studied. The total absence of any corrosion product made it apparent that no corrosion had occurred. The void was present from the date of manufacture and was due to double cell walls that contained contaminant (Fig. 20). The correlation between ultrasonic inspection and the size of the actual void was excellent, as can be seen by comparing Figures 18 and 20.

(a) Dark zone due to contamination from double cell walls illustrated in (b) and (c)

(b) Periphery of no-braze area

(c) Double cell walls

Figure 20. Section of Void Detected by Ultrasonic Inspection of Spoiler S/N 002, Upper Surface (Corresponds to C-Scan of Figure 18)

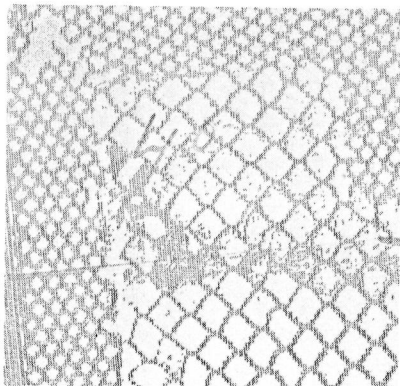
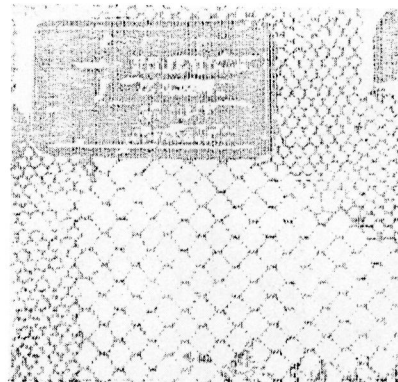
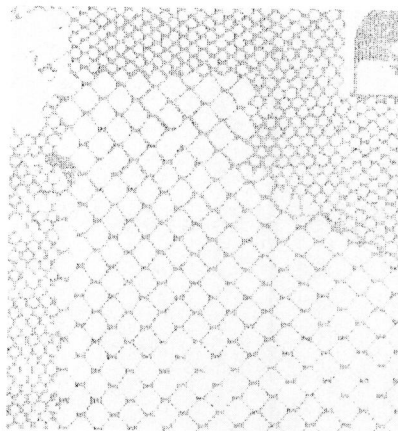
Another, smaller void was observed in the SS 2-20 core in the lower surface of spoiler S/N 003 near the outboard leading edge (Fig. 21). Its maximum dimensions were about 1.3 and 1.7 cm (0.5 and 0.65 in.). The size of this defect could not be determined in 1976, because the part label blocked the scan. This void was considerably larger in 1983, however, as can be seen in Figure 21. It appeared to have extended to the surface and grown to the interior edge of the SS 2-20 core. The disbond on the edge indicated by the C-scan appeared to be more extensive than the three separated cells observed visually.

Figure 21. Pulse-Echo Ultrasonic C-Scans of Spoiler S/N 003, Lower Surface, Showing Braze Defect in Area of Outboard Leading Edge as a Function of Time

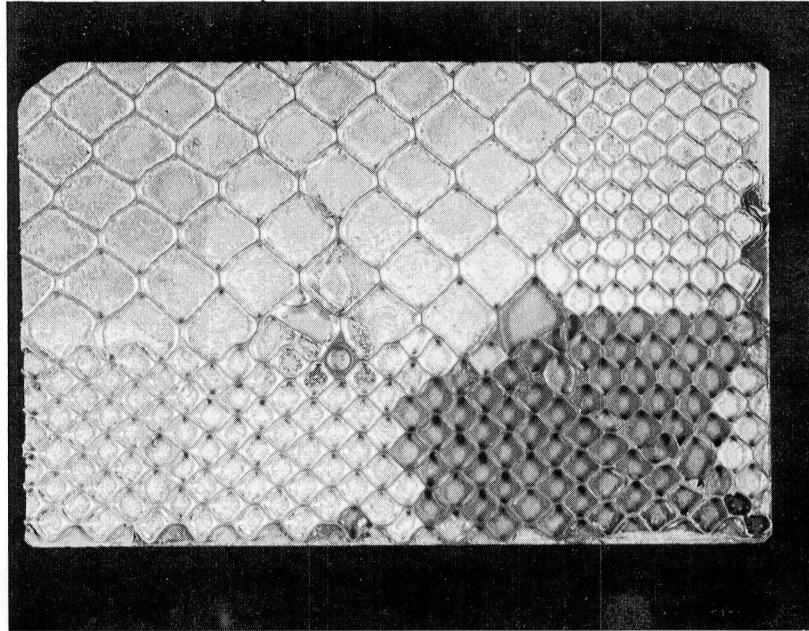
This void also apparently was present from the date of manufacture. The extent of this defect is delineated in Figure 22 by the darkened zone. There are four reasons that it is felt this defect existed from the date of manufacture:

Void corresponds to that observed in figure 21 C-scan

Figure 22. Photomacrograph of Void on Lower Surface Near Outboard Leading Edge, Spoiler S/N 003

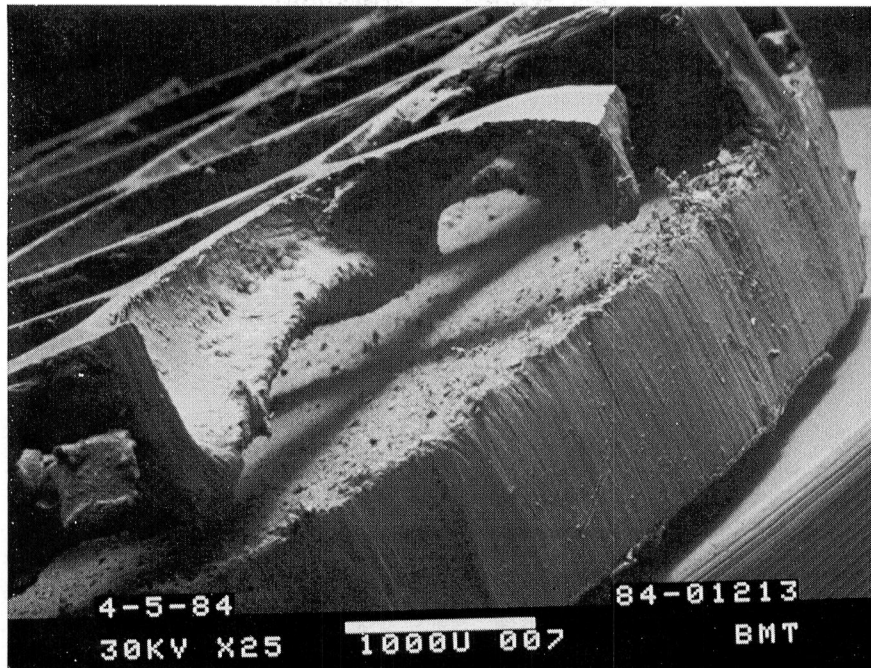
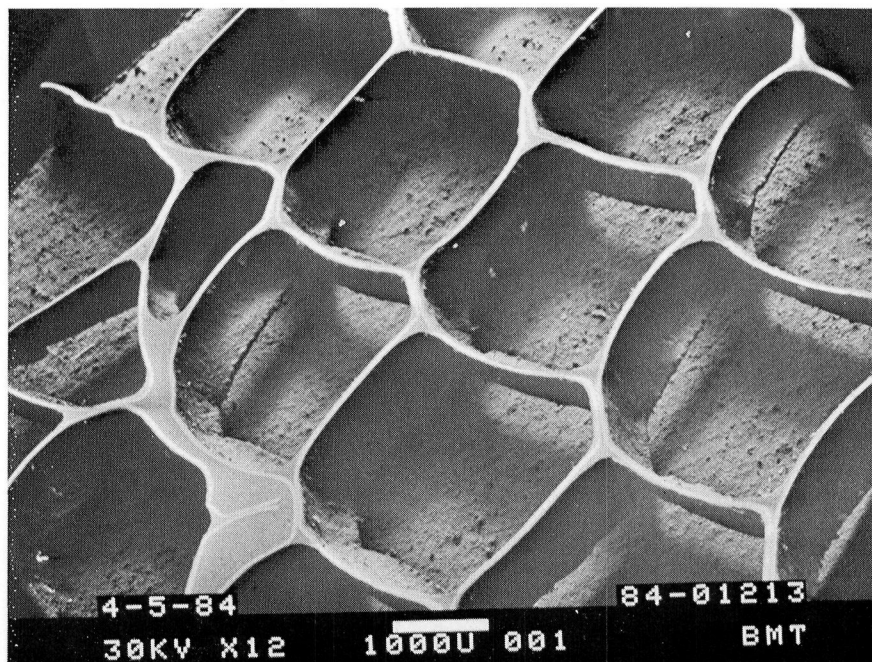
(a) Core distortion that occurred apparently during spoiler fabrication

(b) Standoff (shown by shadows)

Figure 23. Backscattered Scanning Electron Micrographs Illustrating Crushed Core That Prevented Braze Occurrence on Lower Surface of Spoiler S/N 003 Near Outboard Leading Edge (Void from Figure 22)

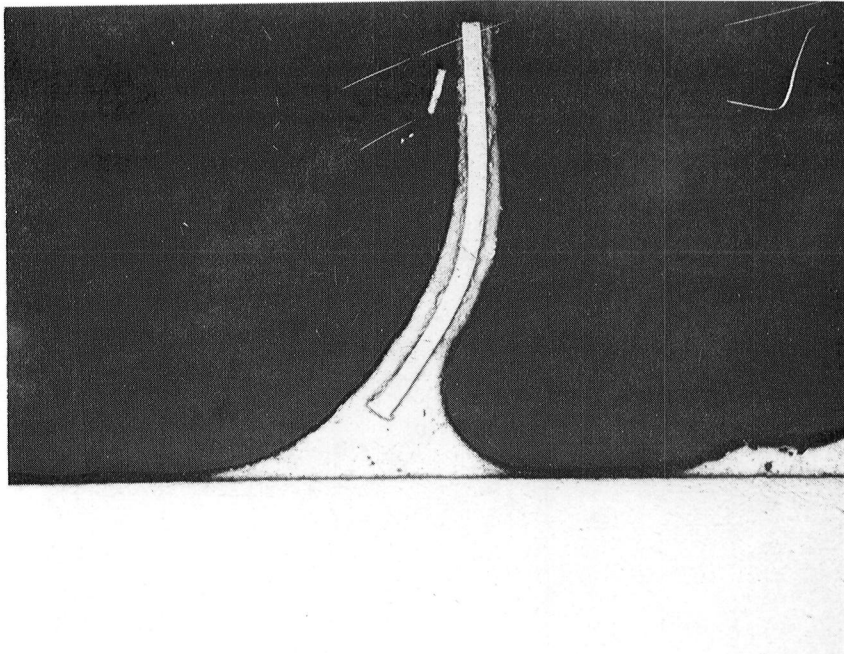
Figure 24. Cross Section at Periphery of Crushed-Core Region Illustrating Cell-Wall Distortion

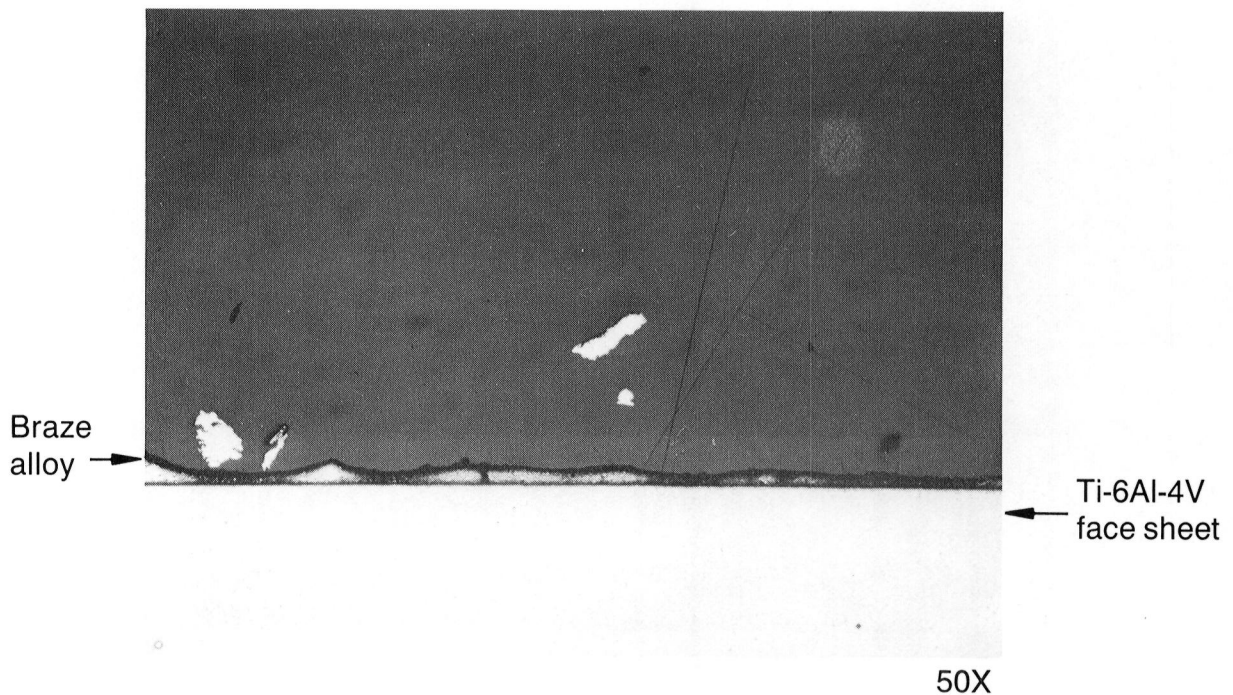
3. Aluminum braze alloy was still present on the face sheet (Fig. 25). If the void grew by a corrosion mechanism, the thin layer of braze alloy present on the face sheet would be gone.

Figure 25. Metallurgical Cross Section Through Center of Void Shown in Figure 22, Illustrating Remnant Braze Alloy on Face Sheet

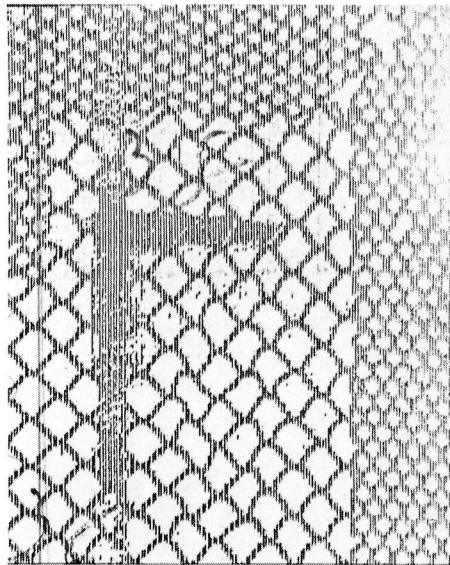
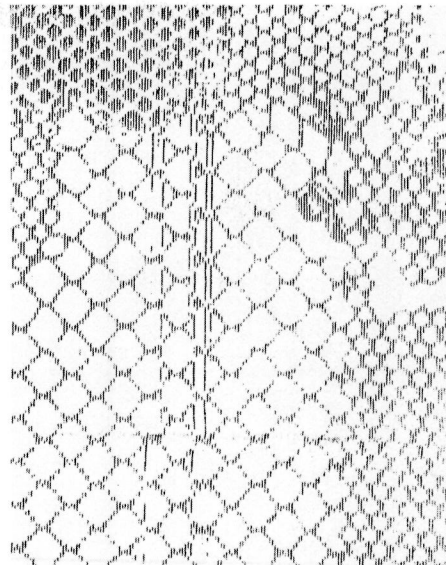
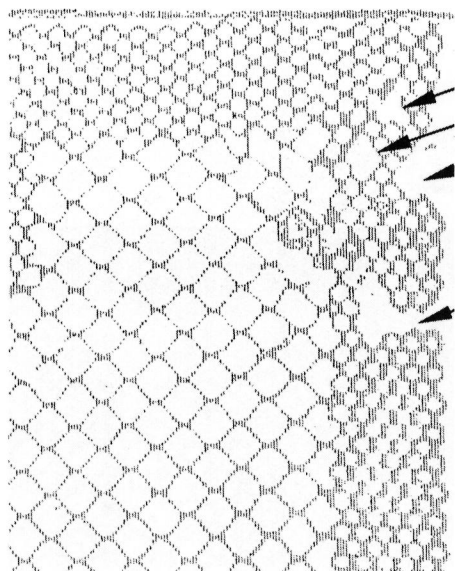
Four voids were detected on the inboard side of the lower surface of S/N 003, as shown in Figure 26. There was no visible evidence of defect A extending to the surface—it was totally internal (Fig. 27). The outer cells of defect A were filled with potting compound, as can be seen in Figure 27a. This would cause an impedance mismatch that could cause a strong echo and produce a void-like appearance. Taking this into account for defect A in Figures 26 and 27, the actual defects again correlated very well with those detected by the C-scan (Fig. 26). Defect B was three cells wide at the surface and corresponded to the external void apparent in Figure 15. All of the voids in this area (A, B, C, and D in Fig. 26) were due to a manufacturing defect, core crushing, which caused a standoff of about 0.5 mm (0.020 in.) that was not bridged by braze alloy. This core-face sheet standoff is illustrated in Figure 27b. The internal surface was bright and shiny, with no evidence of corrosion at any location.

Defect A detected in 1976

Defect B detected in 1983

Figure 26. Pulse-Echo Ultrasonic C-Scans of Spoiler S/N 003, Lower Surface, Showing Braze Defects in Area of Inboard Leading Edge as a Function of Time

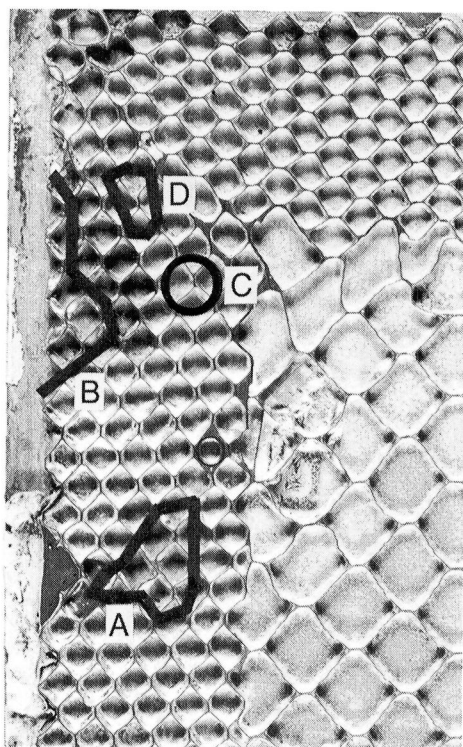
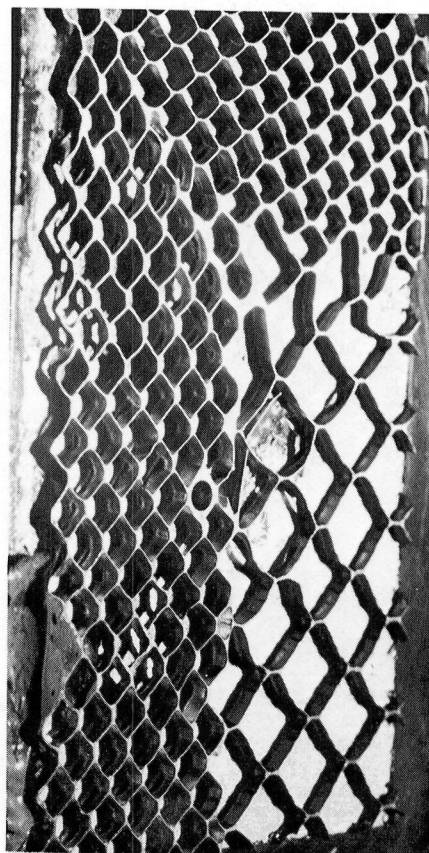
Note: Solid lines in (a) indicate the extent of the voids; letters correlate to figure 26. The cell-wall standoff is apparent by the shadows in (b).

Figure 27. Defects on Lower Surface of Spoiler S/N 003 in Area of Inboard Leading Edge

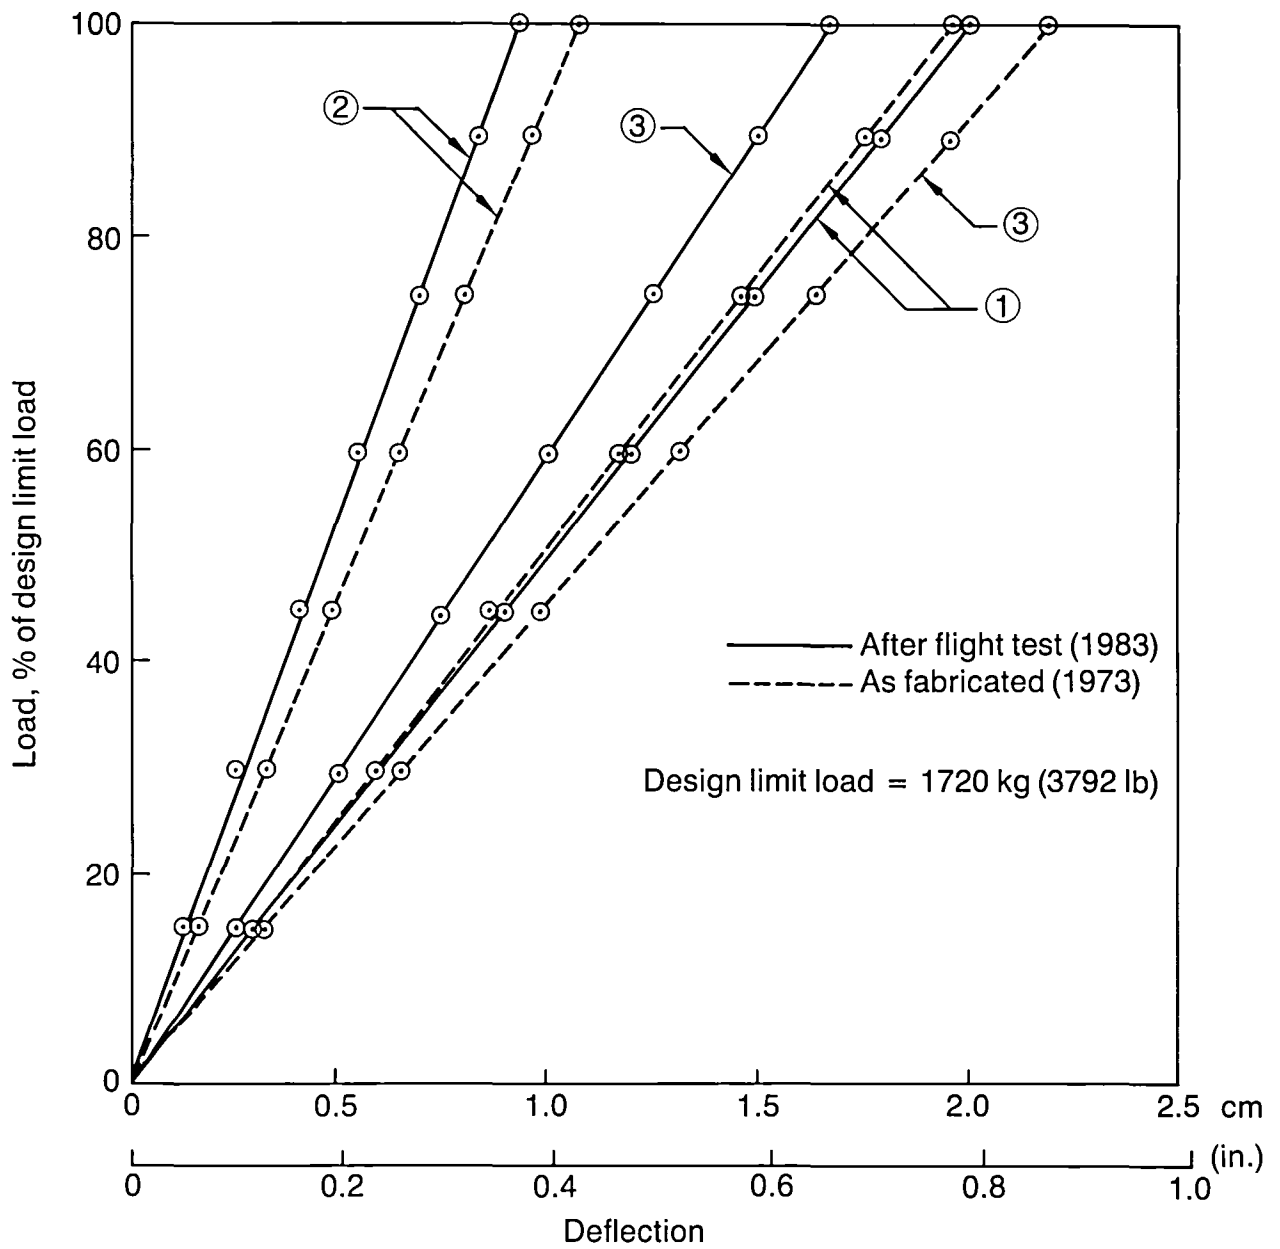
The results are presented in Figures 30 and 31. For both spoilers, the deflections after flight service were less than for the as-fabricated condition, except for location 1 in each case. The preflight and postflight service data for EDI number 1 are probably within experimental error. Both spoilers appeared to be significantly stiffer in location 3, particularly spoiler S/N 002. The only plausible explanation for this is minor differences in load-pad or strain-gage positioning.

Figure 30. Deflection Measurements of Spoiler S/N 002 Before and After Flight Service as a Function of Percentage of Design Limit Load

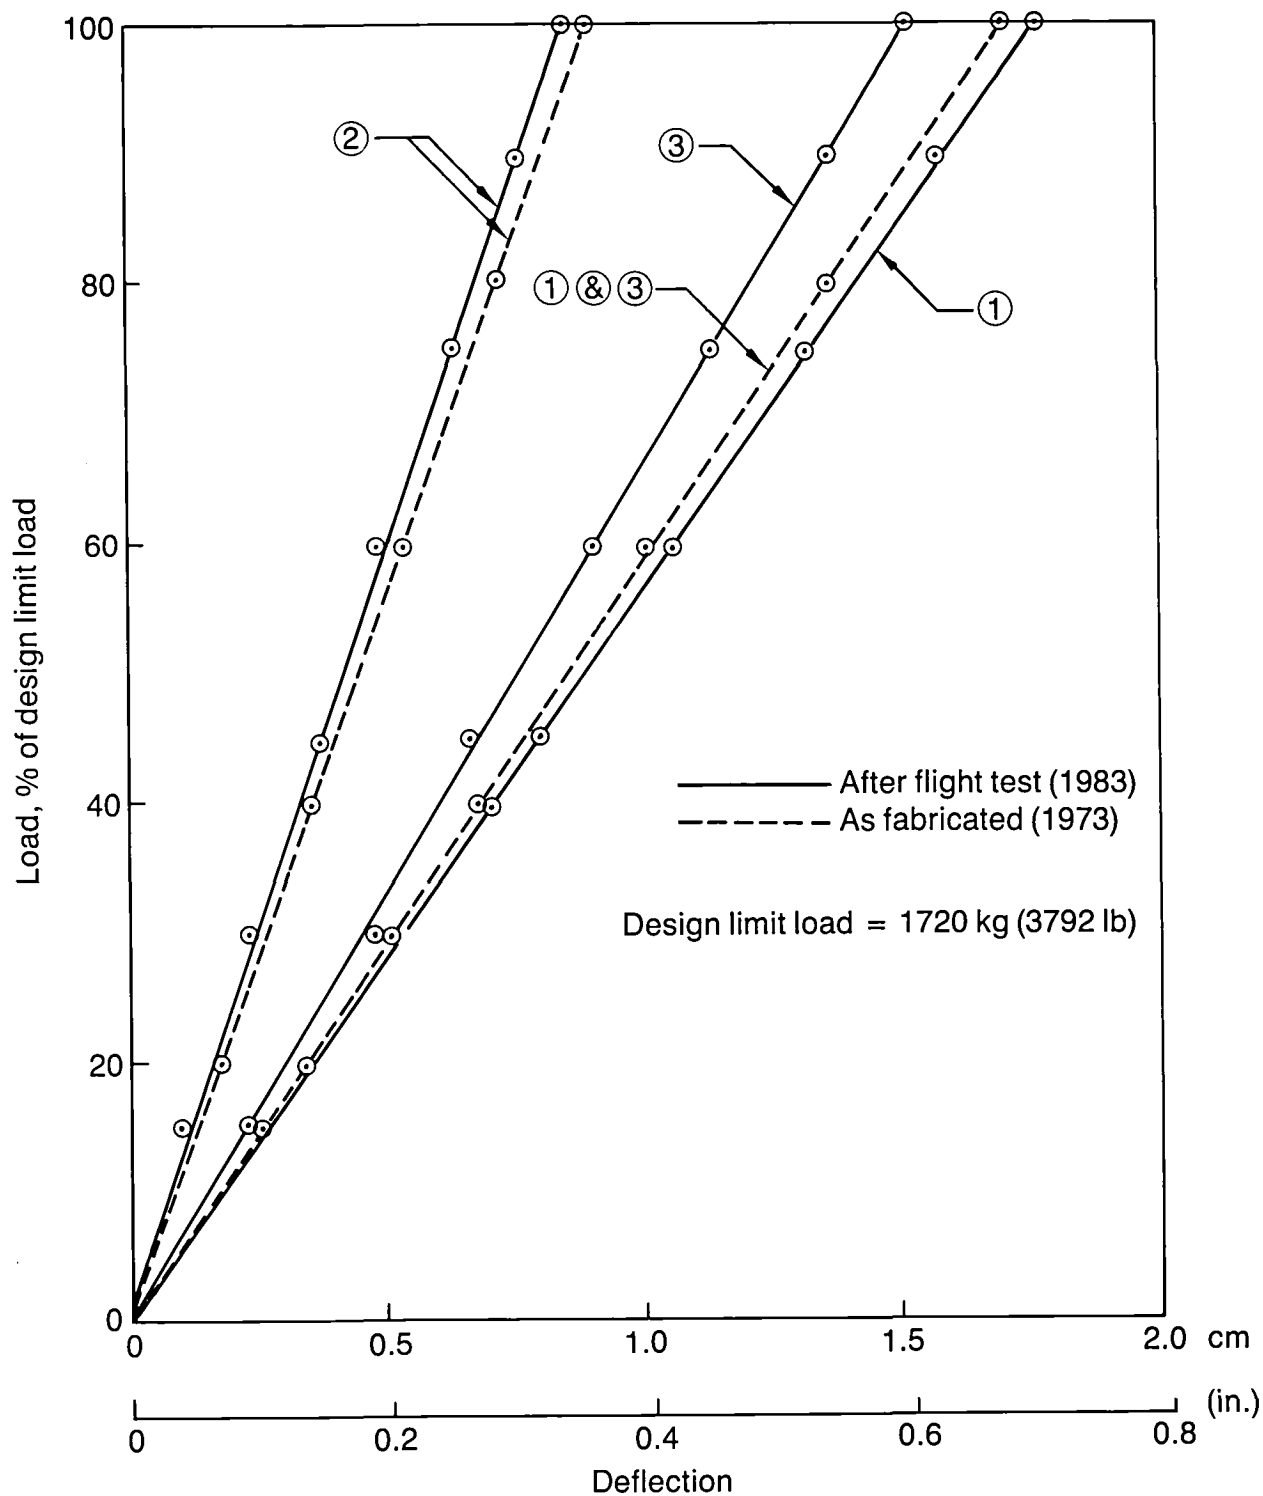
Figure 31. Deflection Measurements of Spoiler S/N 003 Before and After Flight Service as a Function of Percentage of Design Limit Load
